THE KATHMANDU VALLEY PRESERVATION TRUST

## THE RESTORATION OF THE BHANDARKHAL GARDEN & WATER ARCHITECTURE

AT PATAN DARBAR PALACE COMPLEX - A UNESCO WORLD HERITAGE SITE

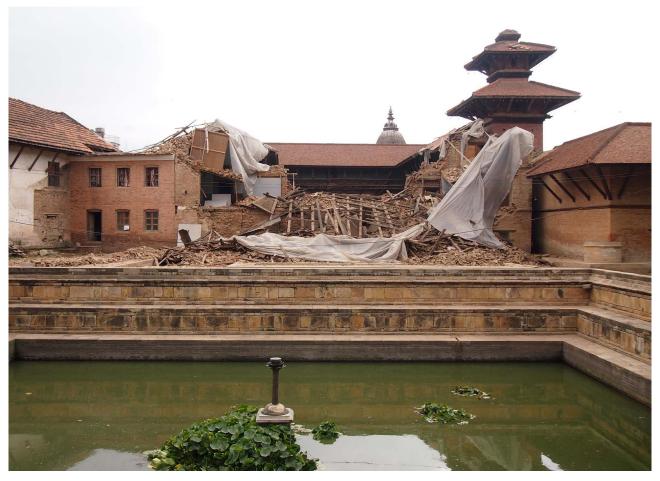
The collapsed East wing of Sundari Chowk Palace | April 25, 2015 The East wing which was built in 1936 was the only palace structure that collapsed. All other and recently restored palace buildings survived the earthquake.

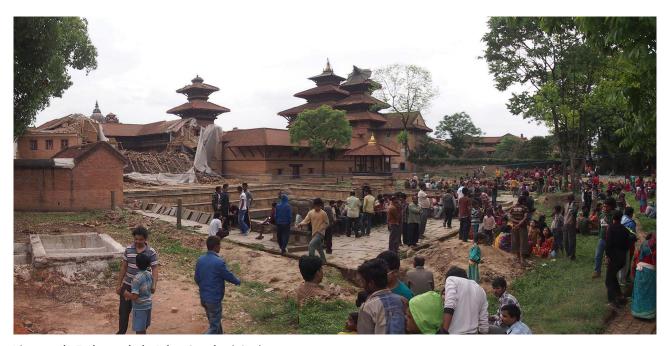
View over the Tank towards the Palace Complex | April 25, 2015 Immediately after the first earthquake people sought refuge in the garden. For over two months more than 50 families who had lost their houses were living in tents in the garden.

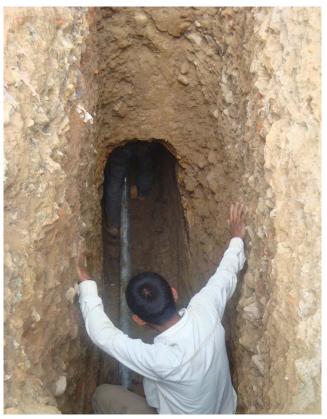
Installation of the new water line | 2015

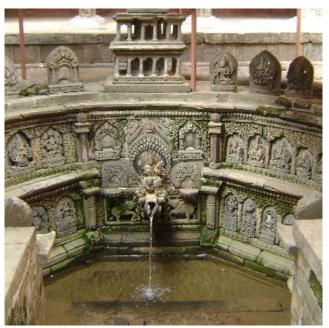
Tusha hiti water spout | 2009 In 2009 the historic water line dating back to the 17th century was still providing clean water even though it dried up during the spring months.

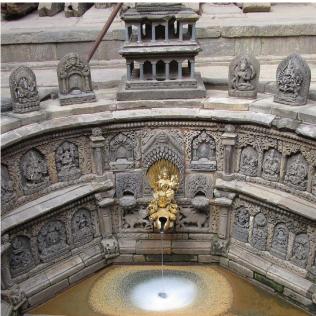
**Tusha hiti water spout** | 2015 Six years later water supply has almost completely stopped. The little water that occaionally runs is heavily polluted.
